**Flood Control Project Maintenance
Levee Inspections**

Fall 2016 Levee Maintenance Deficiency Summary Report

Reclamation District No. 0349 Sutter Island

Fall 2016 Levee Inspection Results

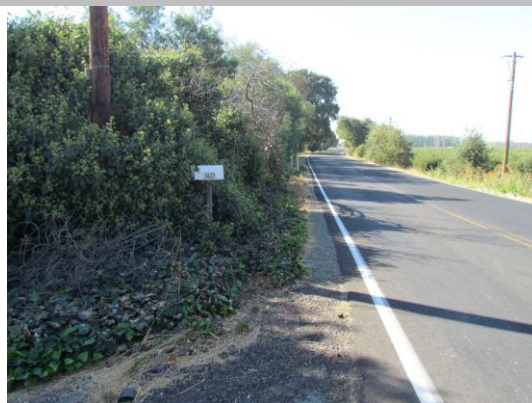
Photo 1 of 1 : FA_2016_RD0349_204_20_20161003_00024.jpg

RD 349 Unit 1 waterside looking downstream at shoulder and slope.

LM Start	0.03	Rating **	M	Issue No.	7
LM End	0.10	Issue Type +	Ma	Location *	WS
Category	Supplemental			GPS Latitude/Longitude	
				Start	End
Item	2015 USACE Erosion Survey, DRAFT			38.326743 °	38.325844 °
				-121.576979 °	-121.577119 °
DWR ID	DWR_RD0349_01_s_2016_7				
Comment Code					
Inspector Comment					
2015: Erosion observed at the toe. [2015 Site ID: SAC_33-9_R]

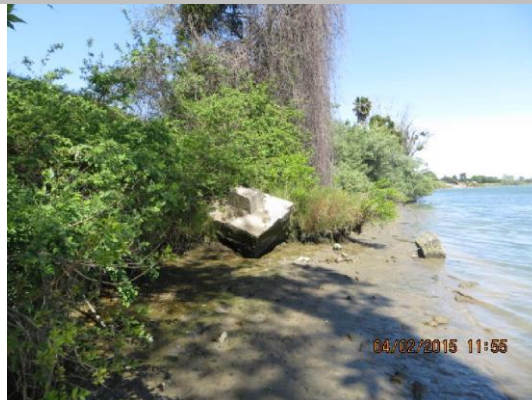
Photo 2 of 2 : UCIP_FA_2016_44303_73621.jpg

Comment Code						
Inspector Comment						
FS_ID:44303						
DS_ID:24137						
EP_NO: N/A						
Repair Type: Non-Urgent						
Crossing Status: Indicator Found						
UCIP Comments: Pipe appears to be abandoned and if so should be done so properly. Electromagnetic survey indicated a crossing at this location.						
FIELD_STRUCT_DESC: *ABANDONED* 10-inch pipe through the levee, 3.8 feet below the crown. Power pole and anchor on the landward side. Deteriorated concrete box at the LS toe. Concrete debris on WS toe good indicator of pump location (USACE-1960). This entry matches the Drainage or Irrigation Structure referenced in O&M manual (HLM 2.74).						
FS Date: 4/2/2015

Concrete debris on WS toe is a good indicator of pump location.

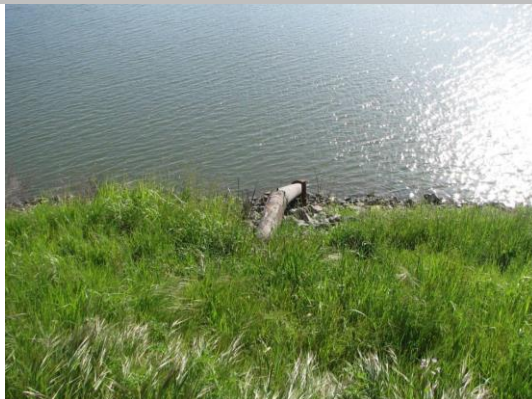
Photo 1 of 2 : UCIP_FA_2016_50062_36547.jpg

Comment Code					
Inspector Comment					
FS_ID:50062 DS_ID:24139 EP_NO: 951 Repair Type: Non-Urgent Crossing Status: Found UCIP Comments: 8/22/2016 Meet Fred Wheeler with RD349 at this crossing. Crossing is active. Crossing was downgraded from Urgent to Non-Urgent -- no signs of pipe failure visible on surface. Need to contact owner -- dense vegetation on WS and LS should be cleared prior to next inspection. Need to coordinate with owner regarding the 8-inch sleeved pipe--need permit number to update record. (DWR UCIP - omagana)3/18/2009 Exposed section of levee slope on LS--need to contact owner and DWR inspector. Burrow activity noticed at crossing 10 inch holes. Dense vegetation limits the inspector's visibility to identify signs of pipe failure (leaks) along the slope. Recommend removing vegetation along pipe alignment to conduct proper inspection of structure and appurtenances. Note date on photos should be 3/18/09 not 7/26/08 camera metadata is incorrect. (DWR UCIP - omagana) FIELD_STRUCT_DESC: 8-inch steel pipe measured (instead of 10-inch) sleeved through a 12-inch steel pipe, 6.6 feet below the crown. Annular gap grouted at both ends. Active centrifugal pump on platform at landside (LS) toe. Inactive slant pump on steel platform on waterside slope (not present in 2008 referenced in USACE O&M manual). Exposed section pipe on WS slope. Service pole on the LS slope. (10-inch pipe sleeved through pre-existing 12-pipe under Permit No. 3382, 1960 - Davis J. Eliot and Son; 12-inch pipe authorized in under Permit No. 951, 1944 - Stillwater Orgards Company). [Additional Reference(s): DWR Levee Log, 2005. USACE San Joaquin O&M Manual Unit No. 110, May 1959, (HLM 0.5)]. FS Date: 8/17/2016

View of pipe on WS with rip rap on toe--dense vegetation on slope.

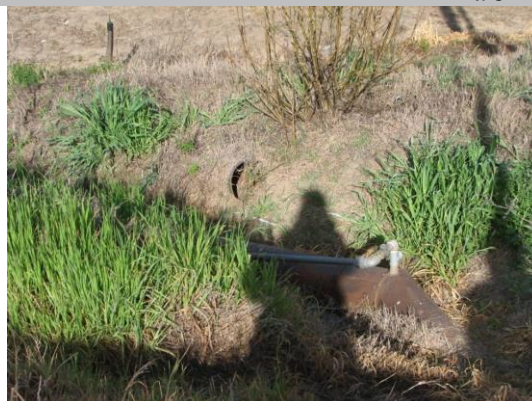
Photo 2 of 2 : UCIP_FA_2016_50062_36546.jpg

View of pipe on LS--open cut section.

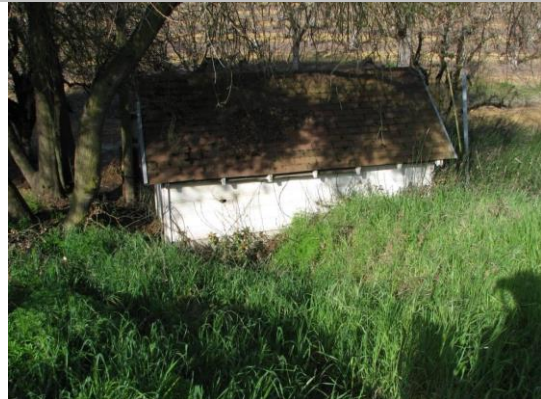
Photo 2 of 2 : UCIP_FA_2016_21572_36573.jpg

FS_ID:21572
DS_ID:24521
EP_NO: N/A
Repair Type: Non-Urgent
Crossing Status: Found
UCIP Comments: No records were found during initial desk study--need to contact owner to obtain permit number authorizing work. If crossing is no longer used by owner, the owner will need to coordinate with DWR Inspector and CVFPB to remove crossing according to Title 23 requirements. Dense vegetation limits the inspector's visibility to identify signs of pipe failure (leaks) along the slope. Recommend removing vegetation along pipe alignment to conduct proper inspection of structure and appurtenances. Note date on photos should be 3/18/09 not 7/26/08 camera metadata is incorrect.
FIELD_STRUCT_DESC: *ABANDONED* 8-inch pipe through the levee, 13.9 feet below the crown. Pump on platform at landward toe. Service pole on landward slope.
FS Date: 3/18/2009

Pump house located on landward side at toe.

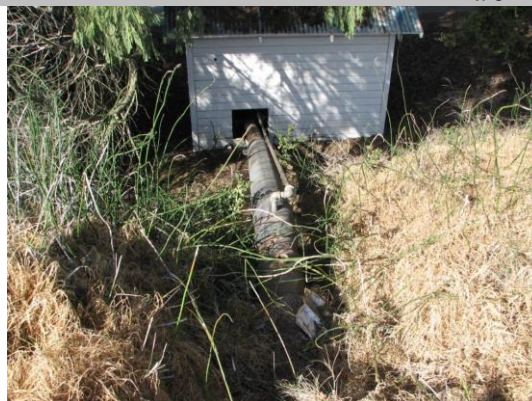
Photo 2 of 2 : UCIP_FA_2016_50013_36558.jpg

FS_ID:50013
DS_ID:24140
EP_NO: N/A
Repair Type: Non-Urgent
Crossing Status: Found
UCIP Comments: 8/22/2016 Crossing has been downgraded from Urgent to Non-Urgent no signs of pipe failure were visible during site inspection. Minor erosion visible on LS shoulder covered by dry leaves. No permit was found--need to contact owner to determine age of crossing and determine when the last internal inspection was completed. (DWR UCIP - omagana)8/13/2009 Exposed section of levee slope on LS--need to contact owner and DWR inspector. Dense vegetation limits the inspector's visibility to identify signs of pipe failure (leaks) along the slope. Recommend removing vegetation along pipe alignment to conduct proper inspection of structure and appurtenances. Note date on photos should be 3/18/09 not 7/26/08 camera metadata is incorrect. (DWR UCIP - omagana)
FIELD_STRUCT_DESC: 14-inch pipe (waterside (WS) shoulder) and 12-inch pipe (landside (LS) shoulder) through the levee, 4.7 feet below the crown. Gate valve on the WS slope. Pump in pumphouse on LS slope. Pressure breaker behind pumphouse. Pipe exposed on WS slope. [Additional Reference(s): DWR Levee Log, 2005. USACE San Joaquin O&M Manual Unit No. 110, May 1959, HLM 1.1]

View of LS slope--open cut.

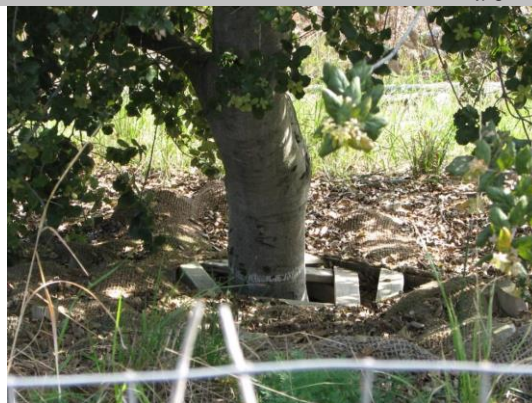
Photo 1 of 2 : UCIP_FA_2016_44304_36580.jpg

Comment Code					
Inspector Comment					
FS_ID:44304					
DS_ID:24141					
EP_NO: N/A					
Repair Type: Non-Urgent					
Crossing Status: Found					
UCIP Comments: 2007 DWR erosion repair site location?--need to find out fate of crossing. Dense vegetation limits the inspector's visibility to identify signs of pipe failure (leaks) along the slope. Recommend removing vegetation along pipe alignment to conduct proper inspection of structure and appurtenances. Note date on photos should be 3/18/09 not 7/26/08 camera metadata is incorrect.					
FIELD_STRUCT_DESC: *ABANDONED* Pumphouse at landward toe. Pressure breaker on landward side. Electromagnetic Survey indicated a crossing at this location as well.					
FS Date: 4/2/2015

Geotech fabric and protective frame at tree--design features of erosion repair site 2007-2009.

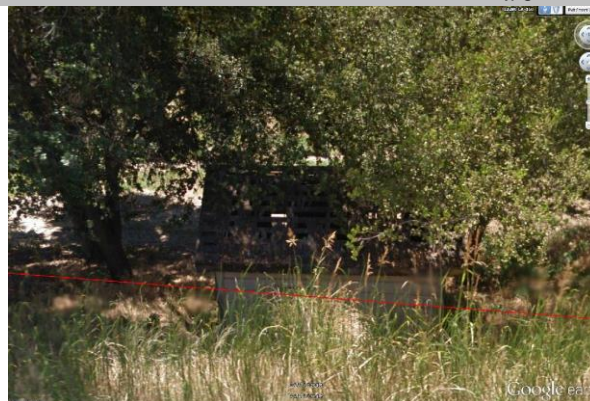
Photo 2 of 2 : UCIP_FA_2016_44304_73625.jpg

Pumphouse on LS toe (From google view)

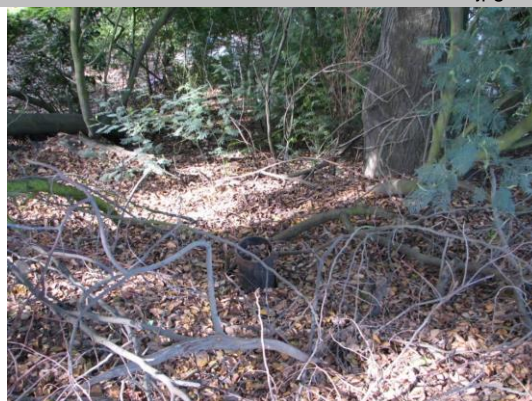
Photo 2 of 2 : UCIP_FA_2016_44214_36571.jpg

FS_ID:44214
DS_ID:24143
EP_NO: 12005
Repair Type: Non-Urgent
Crossing Status: Found
UCIP Comments: Pipe open on WS slope. 2007 Erosion Repair Site location?--Need to contact owner to determine if crossing is still in use. Dense vegetation limits the inspector's visibility to identify signs of pipe failure (leaks) along the slope. Recommend removing vegetation along pipe alignment to conduct proper inspection of structure and appurtenances. Note date on photos should be 3/18/09 not 7/26/08 camera metadata is incorrect.
FIELD_STRUCT_DESC: 6-inch steel irrigation pipe, 4.0 feet below the crown. Siphon breaker and protective housing at levee shoulder. Pump on waterward side. Pipe exposed on waterward slope, extending to pump. Discharge structure at landward toe. (Permit No. 12005-1977)
FS Date: 4/2/2015

Pipe located on landward side--unable to determine whether it belongs to crossing.

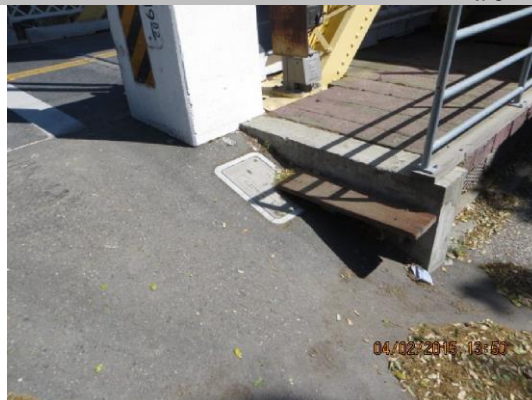
Photo 2 of 2 : UCIP_FA_2016_46168_74543.jpg

FS_ID:46168
DS_ID:25096
EP_NO: N/A
Repair Type: Non-Urgent
Crossing Status: Indicator Found
UCIP Comments: Need to identify permit for crossing.
FIELD_STRUCT_DESC: 2-inch waterline through the levee at an unknown depth below crown. Pipe provides service to bridge and beach (per landowner).
FS Date: 4/9/2015

Christy box on WS shoulder.

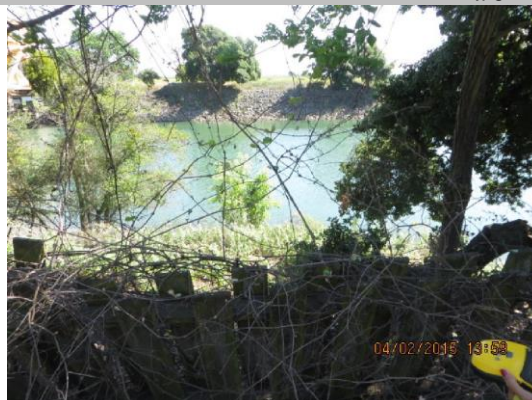
Photo 2 of 2 : UCIP_FA_2016_46169_74546.jpg

FS_ID:46169
DS_ID:25098
EP_NO: N/A
Repair Type: Non-Urgent
Crossing Status: Found
UCIP Comments: Appears abandoned and if so should be done so properly. Need to identify permit.
FIELD_STRUCT_DESC: 1-inch waterline through the levee 1.5-feet below the crown. Pipe visible at fence on WS slope.
FS Date: 4/9/2015

Fence on WS shoulder.

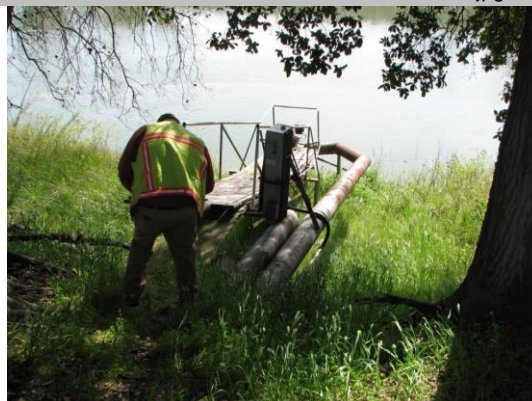
Photo 1 of 2 : UCIP_FA_2016_21576_36593.jpg

Comment Code					
Inspector Comment					
FS_ID:21576 DS_ID:24145 EP_NO: N/A Repair Type: Non-Urgent Crossing Status: Found UCIP Comments: No connection present--need to contact owner to determine if owner plans to use. If crossing is no longer in use owner will need to coordinate with DWR inspector and CVFPB to remove according to Title 23 requirements. Dense vegetation limits the inspector's visibility to identify signs of pipe failure (leaks) along the slope. Recommend removing vegetation along pipe alignment to conduct proper inspection of structure and appurtenances. Unable to determine if crossing is in use. Note date on photos should be 3/18/09 not 7/26/08 camera metadata is incorrect. FIELD_STRUCT_DESC: *ABANDONED* 10-inch pipe through the levee, 6.0 feet below the crown. Pump and slide gate on the waterward slope. Concrete pipe riser and distribution box at the landward toe. Service pole and anchor on the landward slope. FS Date: 3/18/2009

Dense vegetation on waterward slope--2 pipes and 1 conduit.

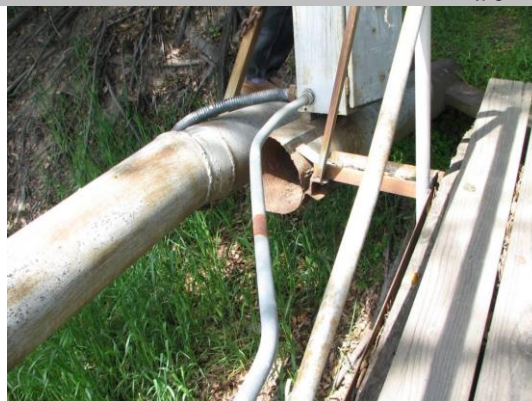
Photo 2 of 2 : UCIP_FA_2016_21576_36592.jpg

Pipes through levee at waterward slope.

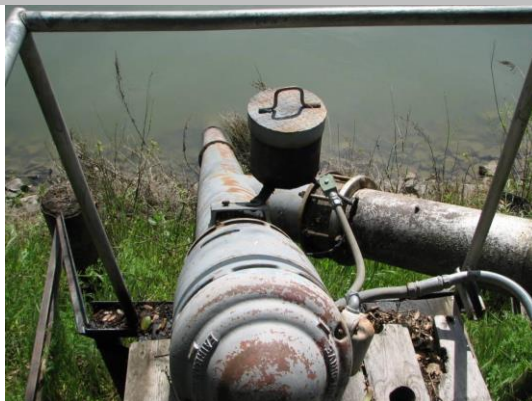
Photo 2 of 2 : UCIP_FA_2016_21577_36596.jpg

FS_ID:21577
DS_ID:24146
EP_NO: 2480
Repair Type: Non-Urgent
Crossing Status: Found
UCIP Comments: Dense vegetation limits the inspector's visibility to identify signs of pipe failure (leaks) along the landward slope. Recommend removing vegetation along pipe alignment to conduct proper inspection of structure and appurtenances. Unable to determine if crossing is in use. Note date on photos should be 3/18/09 not 7/26/08 camera metadata is incorrect.
FIELD_STRUCT_DESC: 10-inch steel pipe through the levee, 6.0 feet below the crown. Pump and slide gate on the waterward slope. Concrete pipe riser and distribution box with gate valve at the landward toe. Service pole and anchor on the landward slope. (Permit No. 2480-1959)
FS Date: 3/18/2009

View of waterward side--pump and raised platform.

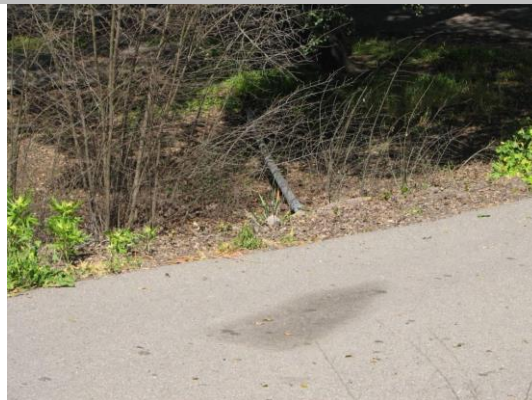
Photo 2 of 2 : UCIP_FA_2016_21613_36687.jpg

FS_ID:21613
DS_ID:24147
EP_NO: N/A
Repair Type: Non-Urgent
Crossing Status: Found
UCIP Comments: Dense vegetation limits the inspector's visibility to identify signs of pipe failure (leaks) along the slope. Recommend removing vegetation along pipe alignment to conduct proper inspection of structure and appurtenances. Note date on photos should be 3/18/09 not 7/26/08 camera metadata is incorrect.
FIELD_STRUCT_DESC: 3-inch pipe through the levee, 3.3 feet below the crown. Gate valve on landward side. (USACE-1959). This entry matches the Drainage or Irrigation Structure referenced in O&M manual (HLM 0.1).
FS Date: 3/18/2009

View of crossing on landward side.

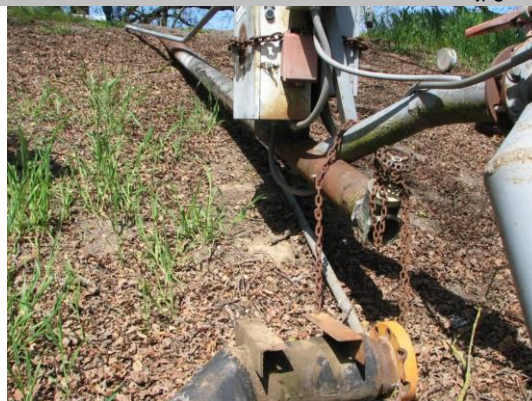
Photo 2 of 2 : UCIP_FA_2016_21614_36690.jpg

FS_ID:21614
DS_ID:24148
EP_NO: 12006
Repair Type: Non-Urgent
Crossing Status: Found
UCIP Comments: Altered crossing--contact owner to obtain new permit authoring work. Debris remains on site. Dense vegetation limits the inspector's visibility to identify signs of pipe failure (leaks) along the slope. Recommend removing vegetation along pipe alignment to conduct proper inspection of structure and appurtenances. Note date on photos should be 3/18/09 not 7/26/08 camera metadata is incorrect.
FIELD_STRUCT_DESC: 6-inch steel irrigation pipe through the levee, 4.0 feet below the crown. 3-inch conduit through levee to service pump. Steel cutoff wall around pipe at center of levee. Siphon breaker in concrete riser at landward shoulder. Gate valve on landward side. Pump on concrete pad on waterward slope. Discharge structure at landward toe. (Permit No. 12006-1977)
FS Date: 3/18/2009

Crossing has been altered--abandoned pipe through levee slope remains.

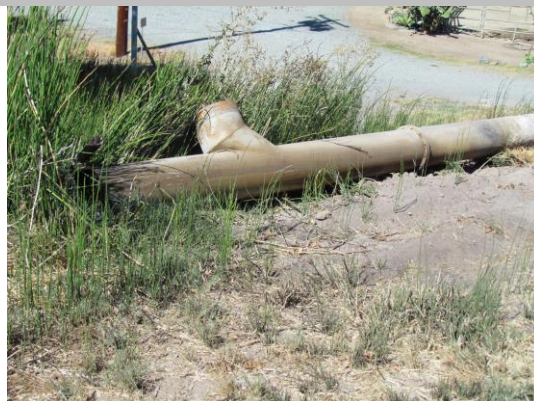
Photo 1 of 1 : FA_2016_RD0349_205_35_20161017_00090.jpg

RD 349 Unit 2 levee mile 1.06 landside toe.

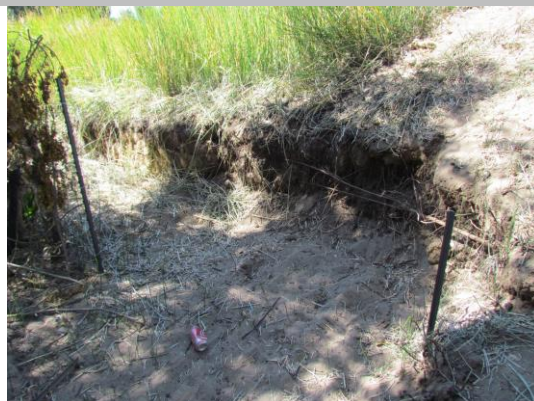
Photo 1 of 3 : FA_2016_RD0349_205_36_20161003_00079.jpg

RD 349 Unit 2 waterside slope and berm Land owner has dug a pit.

LM Start	1.08	Rating **	U	Issue No.	36 (cont)
LM End	1.08	Issue Type +	Ma	Location *	WS

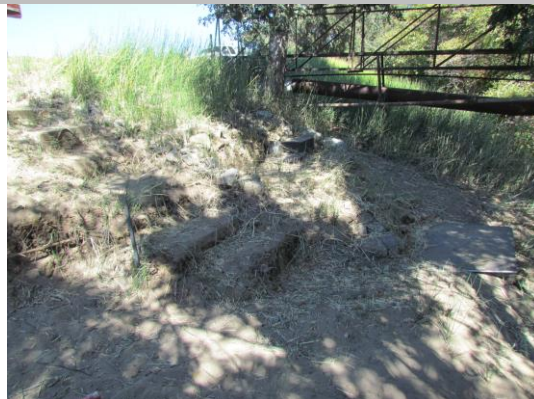
Photo 3 of 3 : FA_2016_RD0349_205_36_20161003_00088.jpg

The landowner has knotted step into the waterside slope.

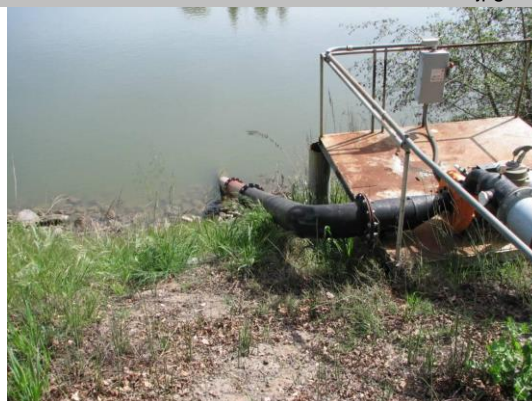
Photo 2 of 2 : UCIP_FA_2016_21607_36659.jpg

Pipe at the waterward toe.

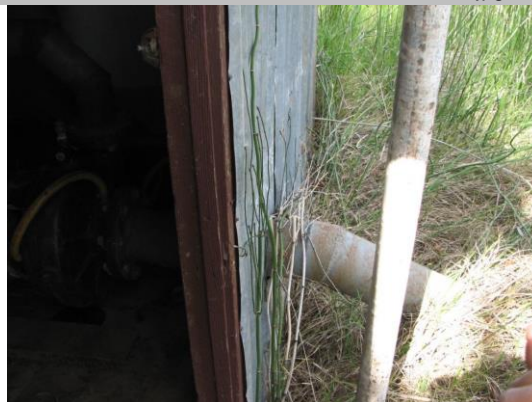
Photo 2 of 2 : UCIP_FA_2016_21608_36663.jpg

View of pipe daylight at shed on waterward side.

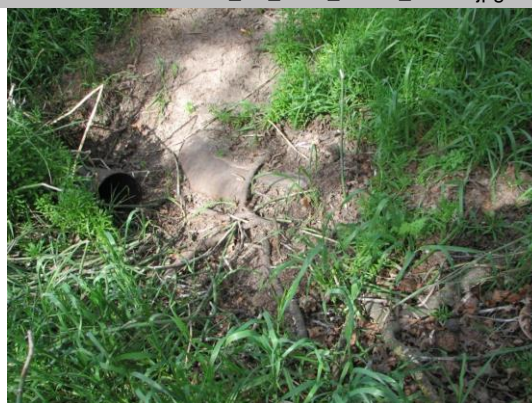
Photo 2 of 2 : UCIP_FA_2016_21609_36667.jpg

Debris along pipe alignment.

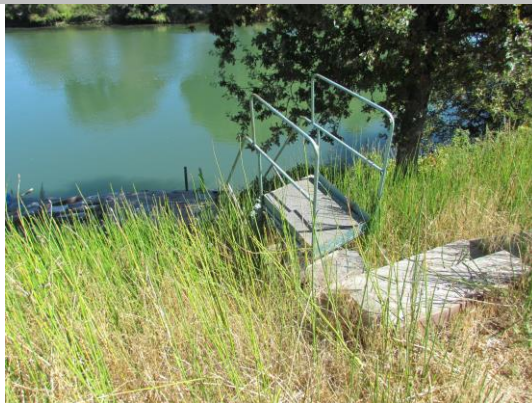
Photo 1 of 3 : FA_2016_RD0349_205_1_20161017_00092.jpg

Unauthorized metal steps on the waterside levee slope at levee mile 2.39.

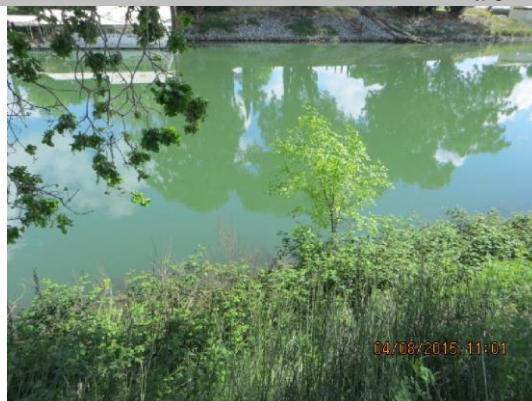
Photo 1 of 2 : UCIP_FA_2016_44328_73707.jpg

Pipe visible in water at WS toe.

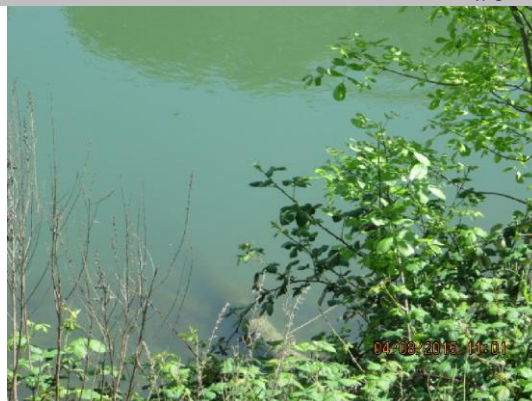
Photo 2 of 2 : UCIP_FA_2016_44328_73706.jpg

Pipe visible in water at WS toe.

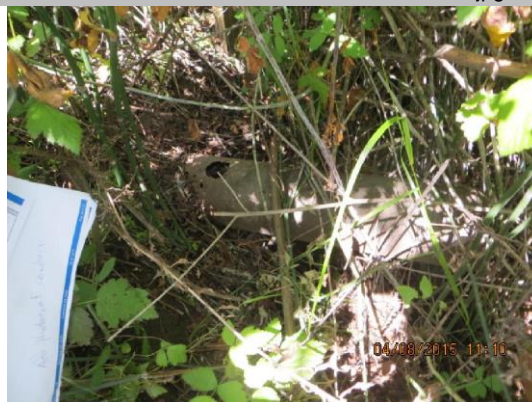
Photo 2 of 2 : UCIP_FA_2016_50015_73708.jpg

Abandoned pipe visible on slope in vegetation behind new pipe on WS slope.

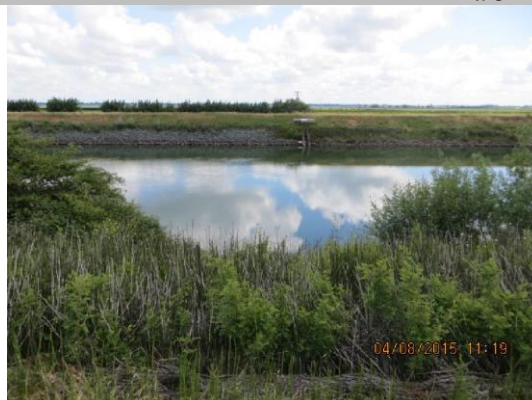
Photo 2 of 2 : UCIP_FA_2016_46172_74554.jpg

View of WS from shoulder at crossing. Pipe not found on WS.

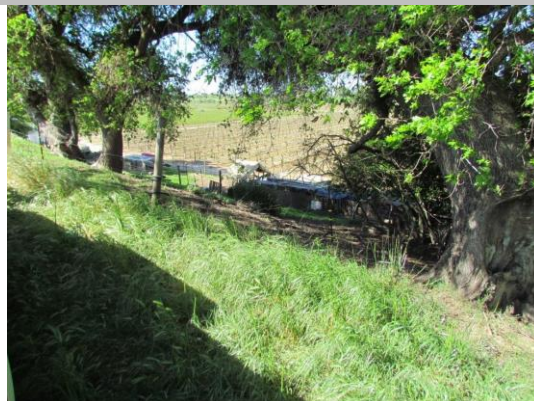
Photo 3 of 4 : FA_2016_RD0349_205_59_20160913_00018.jpg

Unauthorized electric fence installed along the landside shoulder and slope.

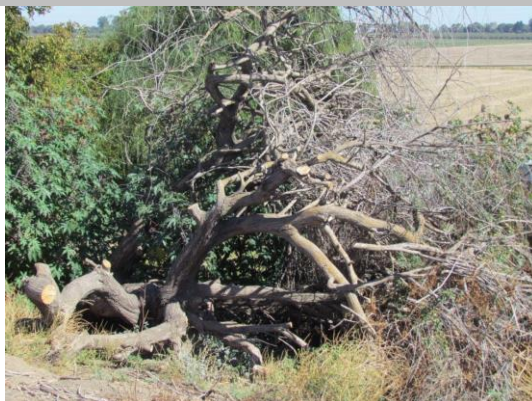
Photo 1 of 1 : FA_2016_RD0349_206_971_20160913_00007.jpg

The dead tree listed in last inspection has not been completely removed, nor has the woody tree growth been thinned out.

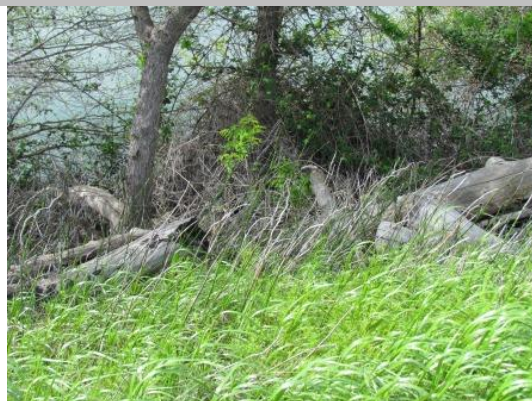
Photo 1 of 1 : FA_2016_RD0349_206_64_20160913_00003.jpg

Cut up fallen tree on waterside slope.

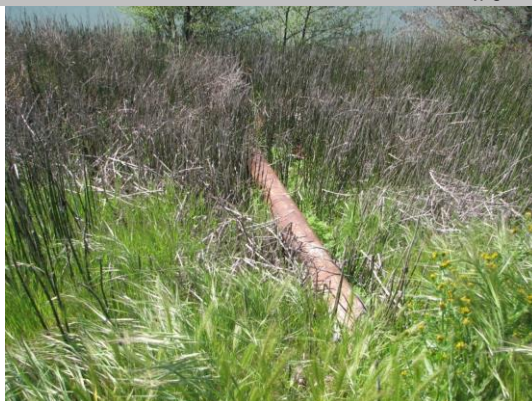
Photo 2 of 2 : UCIP_FA_2016_21634_36738.jpg

View of waterward side--dense vegetation limits inspection.

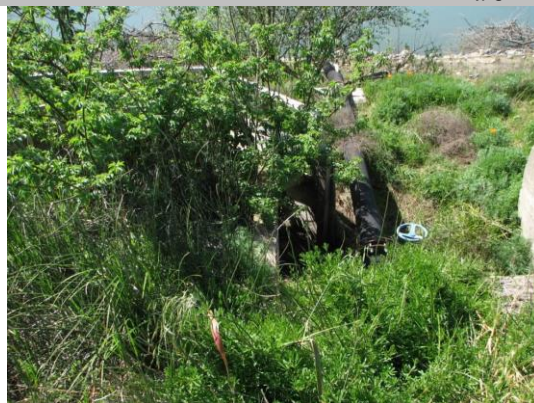
Photo 1 of 2 : UCIP_FA_2016_43424_36869.jpg

Waterward side--appears to be an erosion repair site. New pipe on waterward side and damaged pipe on landward side.

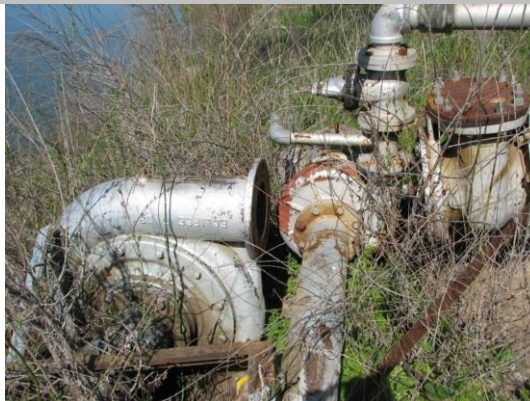
Photo 2 of 2 : UCIP_FA_2016_43459_36795.jpg

Pump located on waterward side is not connected.

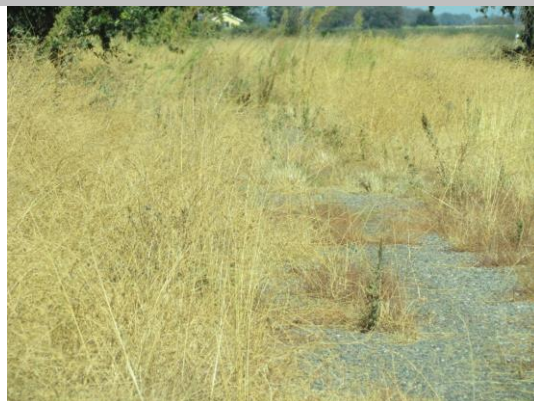
Photo 1 of 1 : FA_2016_RD0349_206_80_20160913_00006.jpg

RD 349 Levee mile 4.74 looking at overgrown crown roadway. Weeds are taller than four feet. Extreme fire hazard.
